Test Report No. 7191087454-EEC14-CSL
dated 06 Jun 2014

Testing of Office Chair submitted by Merryfair Chair System Sdn Bhd on 12 May 2014.

ANSI/BIFMA X5.1-2011 "General-Purpose Office Chairs – Tests"

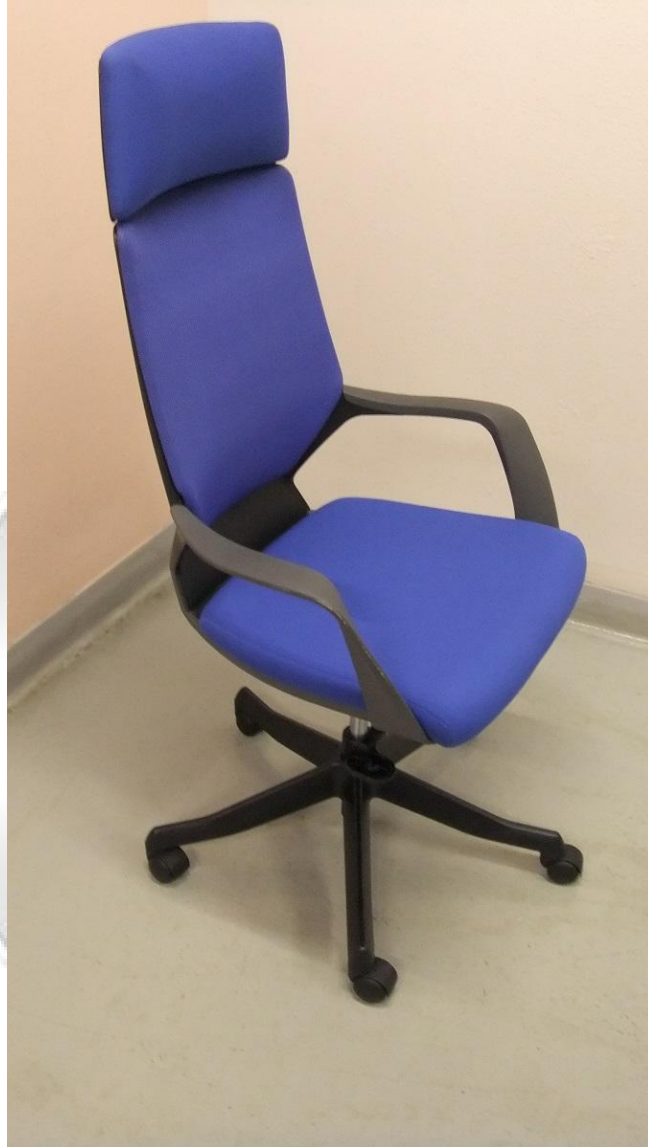
Photograph : APOLLO Office Chair

Three complete sets of Office Chair as shown in the photograph was received. The following descriptions were given by the client:

Model	:	APOLLO
Product Type	:	Office Chair
Country of Origin	:	Malaysia
Classification	:	Type I (when tilt mechanism is unlocked) Type III (when tilt mechanism is locked)
