Test Report No. 7191059426-MEC13-CSL
dated 22 May 2013

Testing of Chair submitted by Merryfair Chair System Sdn Bhd on 25 Apr 2013 and 16 May 2013.

Model	:	JUVEL
Product Type	:	Office Chair
Country of Origin	:	Malaysia
Classification	:	Type III

ANSI/BIFMA X5.1-2011 "General-Purpose Office Chairs – Tests"

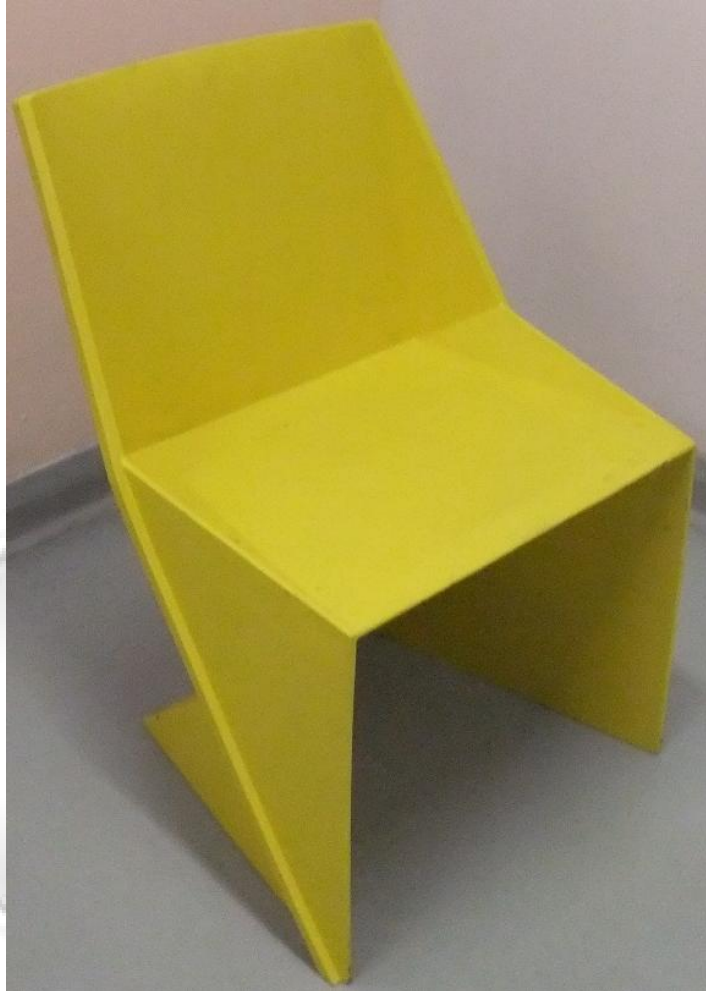
One complete set of Chair as shown in the photograph was received.
The following descriptions were given by the client:

Photograph : JUVEL Office Chair
