**Test Report No. 7191010724-MEC11-OCS**  
dated 22 Sep 2011

Testing of Office Chair submitted by Merryfair Chair System Sdn Bhd on 14 Jun 2011.

ANSI/BIFMA X5.1 – 2002 "General-Purpose Office Chairs – Tests"

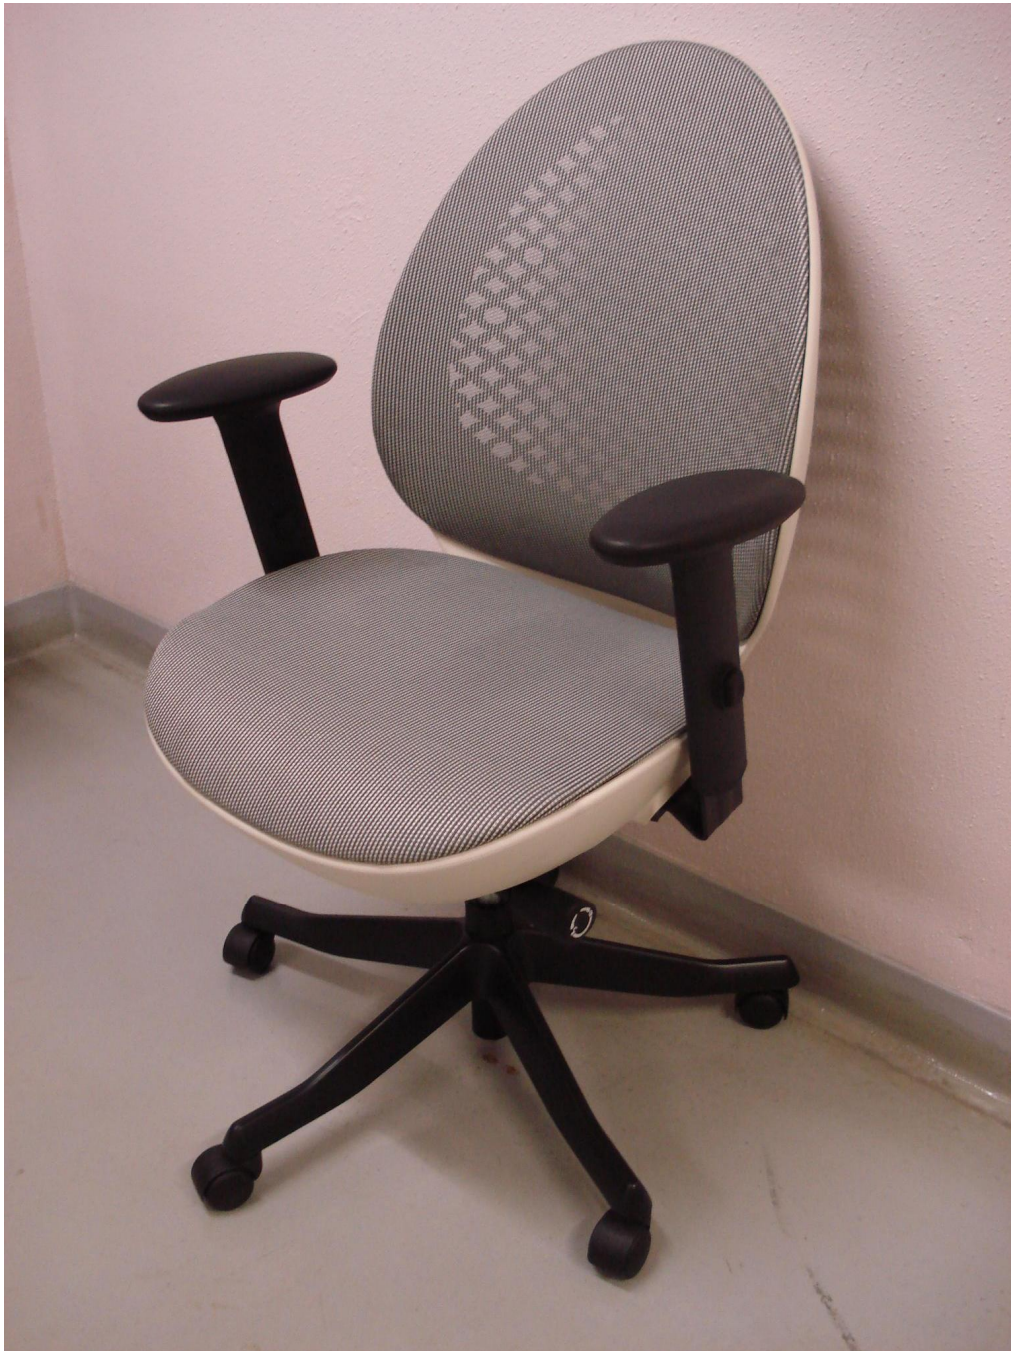
Photograph 1 : Ovo

Two complete sets of Office Chair as shown in the photograph 1 were received. The following descriptions were given by the client:

Model : Ovo  
Product Type : Office Chair  
Country of Origin : Malaysia
