Test Report No. 7191068569-MEC13/01-CSL
dated 12 Nov 2013

Testing of Office Chair submitted by Merryfair Chair System Sdn Bhd on 16 Aug 2013, 30 Sep 2013 and 23 Oct 2013.

ANSI/BIFMA X5.1-2011 "General-Purpose Office Chairs – Tests"

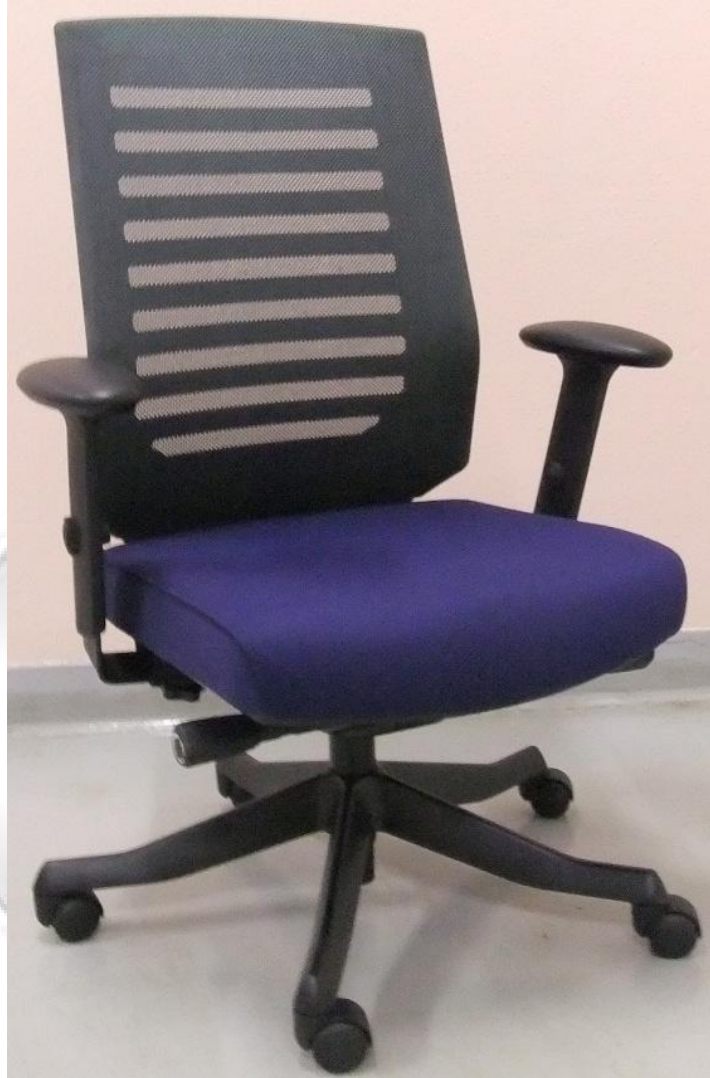
One complete set of Office Chair as shown in the photograph was received. The following descriptions were given by the client:

Model	:	VELO
Product Type	:	Office Chair
Country of Origin	:	Malaysia
Classification	:	Type I (when tilt mechanism is unlocked) Type III (when tilt mechanism is locked)

Photograph : VELO Office Chair
